# Insulation That Works

*With closed-cell spray foam, the benefits go way beyond R-value*

**T** by Steve Easley

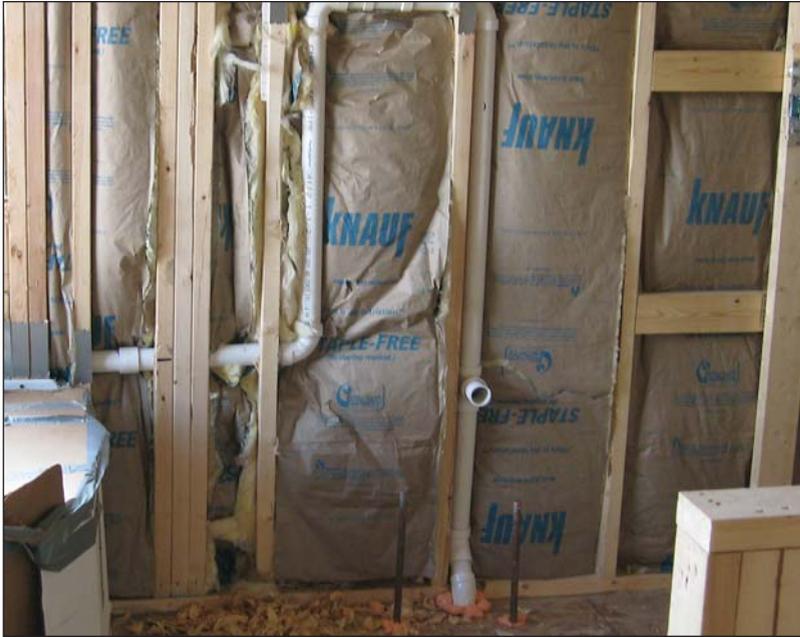
Batt insulation works best when it is fully lofted, not jammed into the tight spaces (left). Compression of the batt reduces the number of air pockets that provide the material's insulation value. It also leaves a hollow between the insulation and the dry-wall, creating areas where air can circulate. These voids can siphon off energy and may create conditions for condensation and moisture problems.

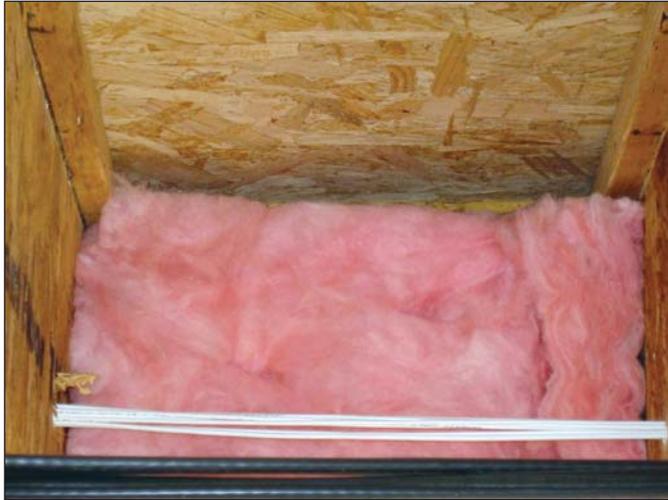
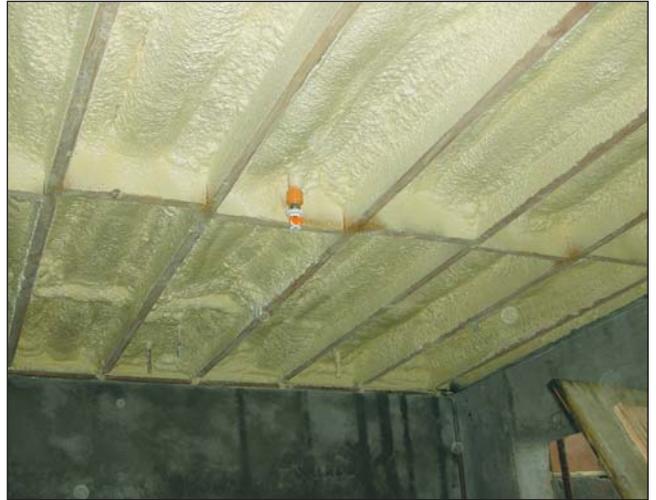
## Living Spaces Over Garages

Living spaces over garages create conditions that demand careful attention to insulating the floor. Yet it is difficult to support the insulation in this cavity, and oftentimes the insulation falls onto the garage ceiling. This separation between the insulation and the living space floor creates a thermal bypass that compromises the value of the insulation. Air easily infiltrates in at the band-joint area over the top of the insulation, which scavenges away heat. This often freezes plumbing pipes, creates cold floors, and can lead to major mold and water damage. Builders often try to solve the problem by supplying forced-air heat near the plumbing, but this only succeeds in pressurizing the space with warm, humid air. As this air exfiltrates through the exterior cracks, it can condense and lead to even worse moisture and mold problems at the band-joint areas.

The issues are easily solved with ccSPF, which sticks to the bottom of the subfloor so insulation and air barrier are always in contact. The foam also stops air infiltration. It is a good idea to wrap any plumbing with a thin layer of fiberglass insulation before spraying foam over it to make servicing the plumbing easier.

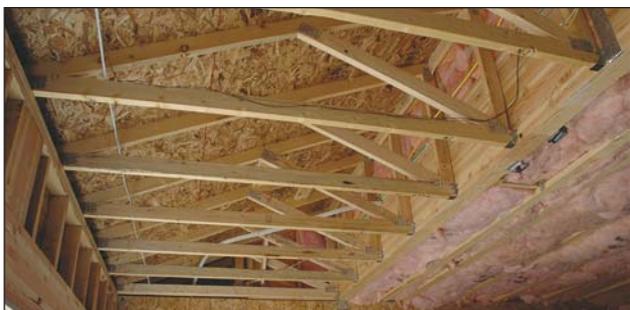
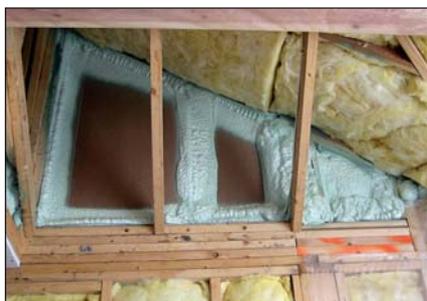
### Attic Knee Walls

These are areas where the insulation on the back side of unsheathed walls is exposed to outdoor temperatures and airflow. They are often adjacent to ventilated attic areas.

The Energy Star Thermal Bypass Inspection Checklist requires that an air barrier be placed on all sides of the insulation. This means that the back sides of knee walls need to be sheathed and sealed. Thin-profile cardboard sheathing with ccSPF works well here. Since ccSPF is air impermeable, the insulation does not have to fill the entire cavity, and it meets the air barrier requirement. Some codes require R-19 insulation, which is difficult to do in a 3½-inch space with batt insulation, but 2 inches of ccSPF provides about R-19.5.

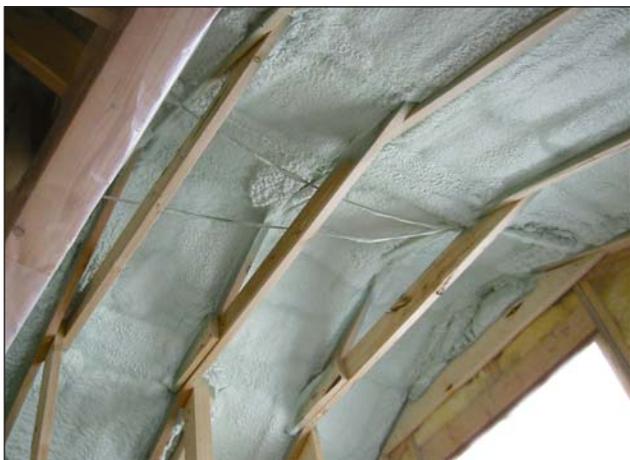
### Sloping Roof Areas

The sloping areas in a cathedral ceiling can be the sites for significant thermal bypasses. These areas are not only difficult to insulate but are difficult to ventilate. Yet ccSPF solves both problems. Placing ccSPF directly on the underside of the roof deck also creates a secondary rain barrier, and because of ccSPF's high R-value and low permeability, moisture is not likely to condense on its surface, eliminating the need for cavity ventilation.

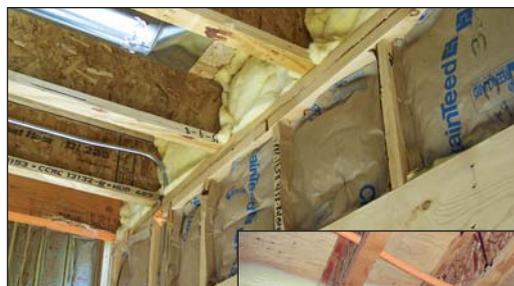
### Band-Joint Areas

The band-joint area is typically a major site for air infiltration. These areas are usually very poorly insulated, causing one of the most significant thermal bypass areas. If the home is under a positive pressure (air pushing out from inside) in a heating climate, the air is likely to be at a high humidity level. This can cause frost, and eventually mold, to build up on the back side of the band joist. In a cooling climate that is under negative pressure (air pulled inward — a condition that's commonly caused by leaky HVAC ducts), this can pull hot, humid air from outside, where it is likely to condense and lead to mold problems. The sealing properties of ccSPF will reduce these air-infiltration and energy-loss problems in this troublesome area.

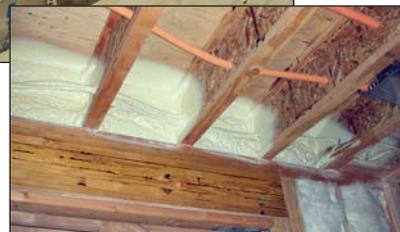
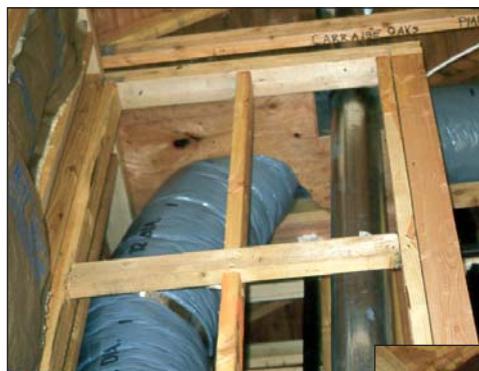
### Attic and Crawlspace Bypasses

Attic and crawlspace bypasses are penetrations into the living spaces. Pipes, ducts, flues, and electric wires are the most common reason for these penetrations, and the best way to seal them is often (but not always) with ccSPF. Because ccSPF expands and seals, it does an excellent job of filling voids that allow conditioned air to escape. However, ccSPF should *not* be used to seal around high-temperature areas such as combustion appliance flues.

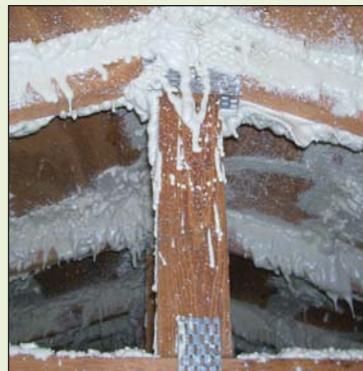
When a roof is not likely to be replaced anytime soon and the sheathing nailing can't be verified (on a tile roof in good condition, for example), contractors in Florida are beginning to employ the “fillet method.” This practice uses closed-cell spray foam to help bond the roof sheathing to existing framing and provide a secondary water barrier.
